Figure 8
Regional
Subsidence

CWC CAP
Water Delivery System

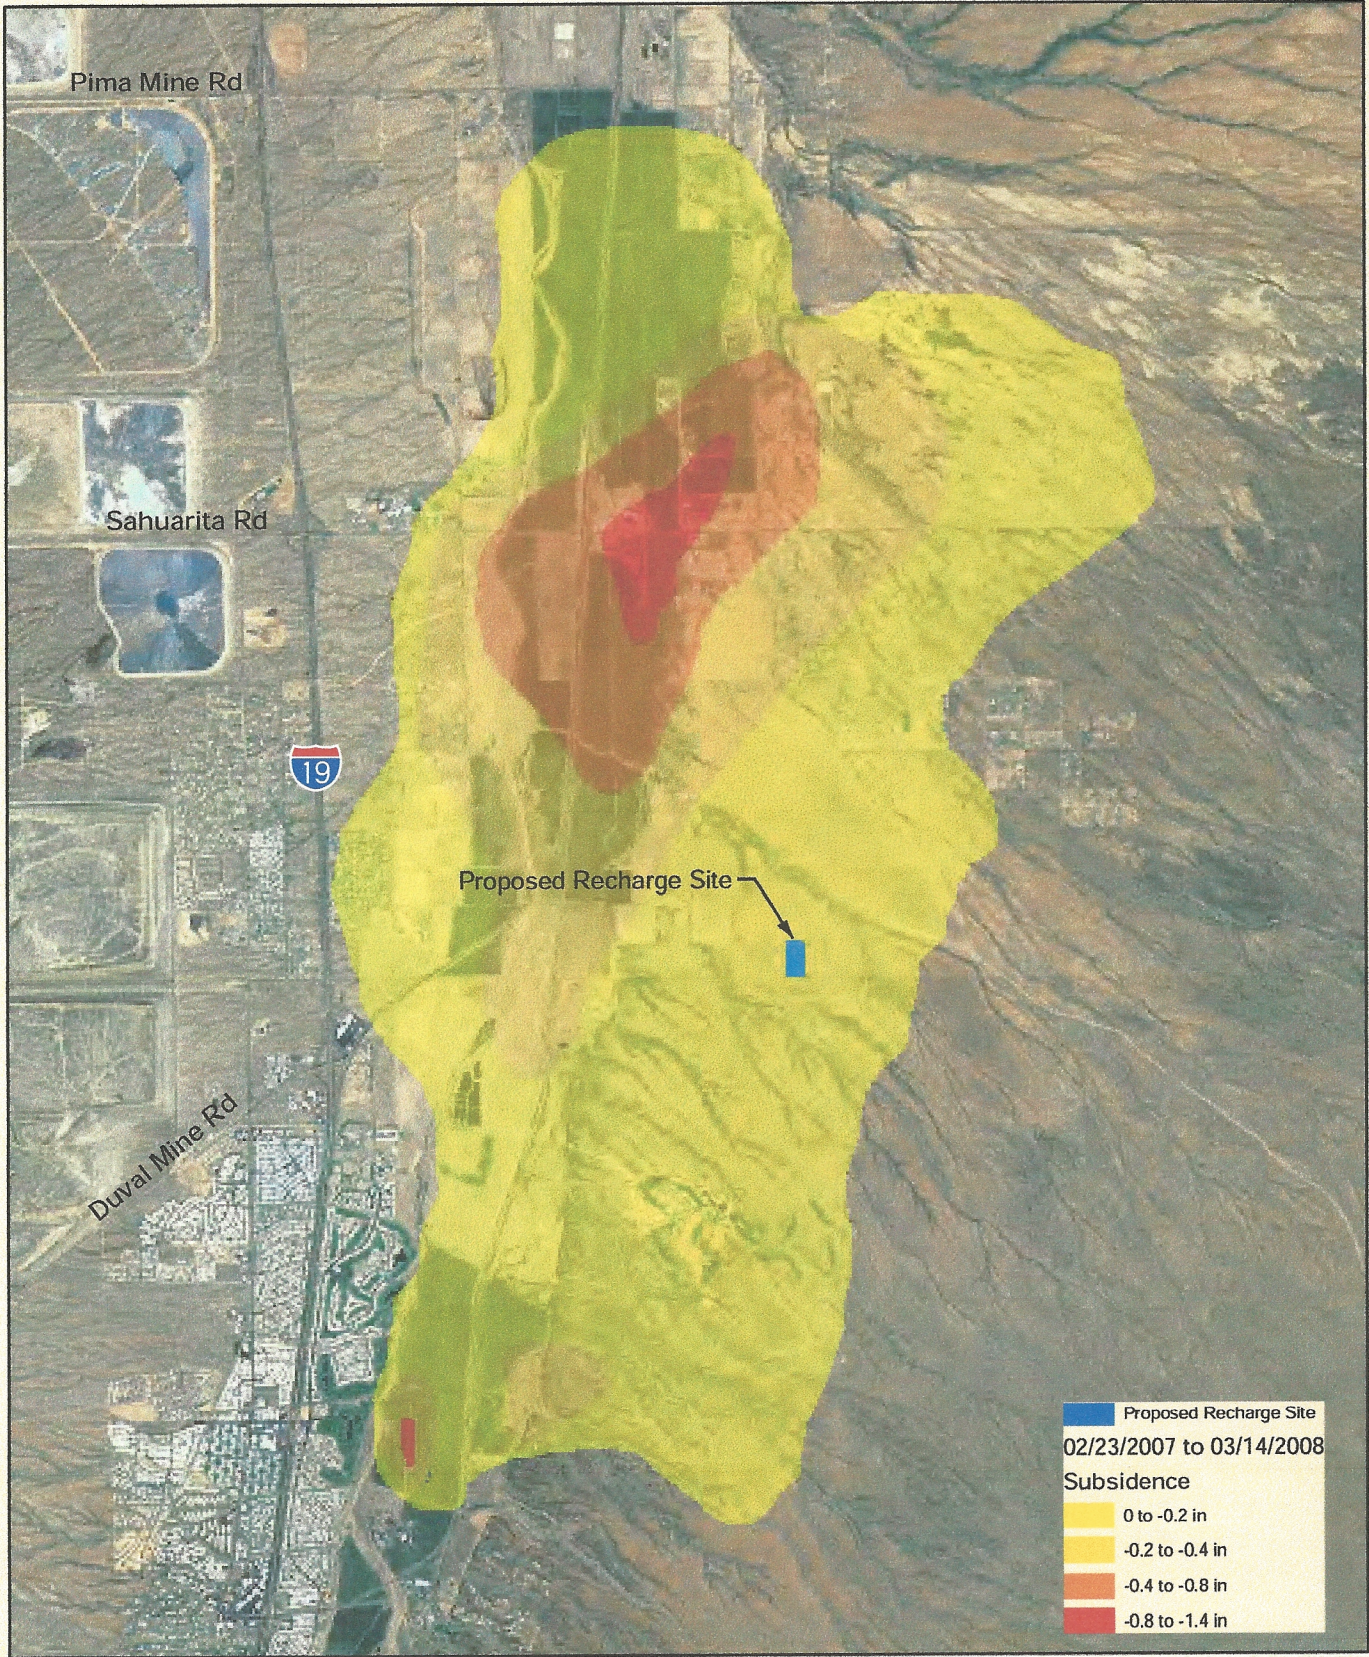
■ Proposed Recharge Site
 02/23/2007 to 03/14/2008
Subsidence
■ 0 to -0.2 in
■ -0.2 to -0.4 in
■ -0.4 to -0.8 in
■ -0.8 to -1.4 in
